Heat Exchanger Tube Bundle Sample Extraction

Project Report

Procurement and Installation of Inductosense Probes to Automate Agbami Topside Riser Elbow Wall Thickness Measurements

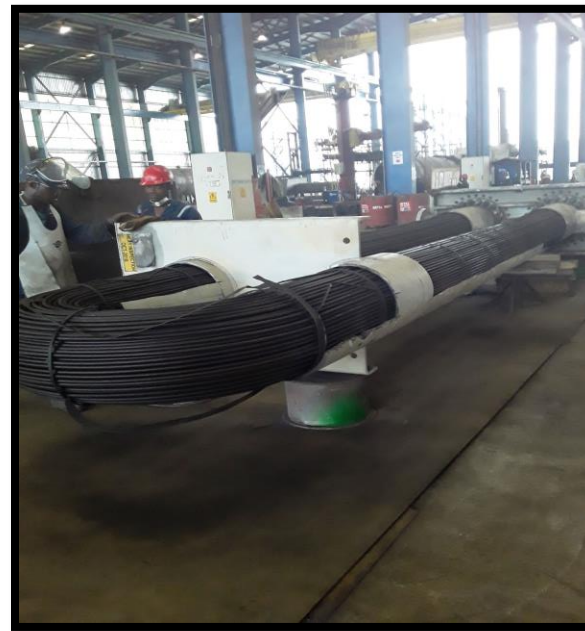
Exposed tubes for Visual Inspection

- Marking out portions of exchanger shell for cutting.
- Cutting and opening of the HEX shell, exposing the tubes for visual inspection.
- Marking of tubes for sample extraction

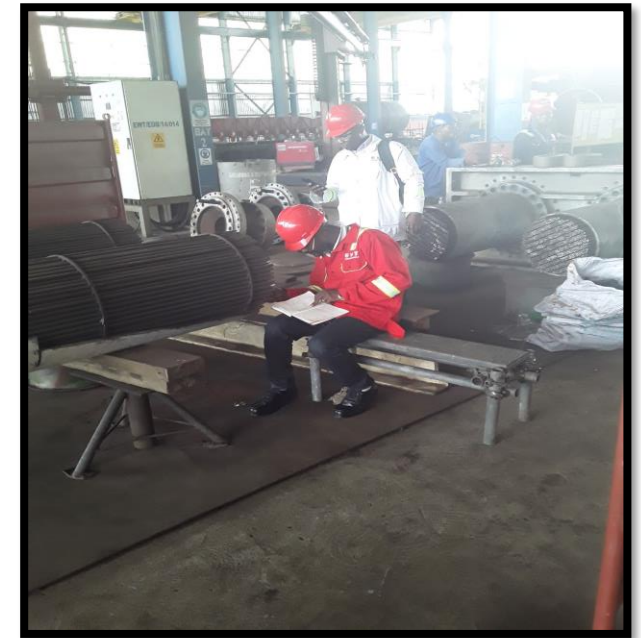
Selecting tubes for Sample Extraction

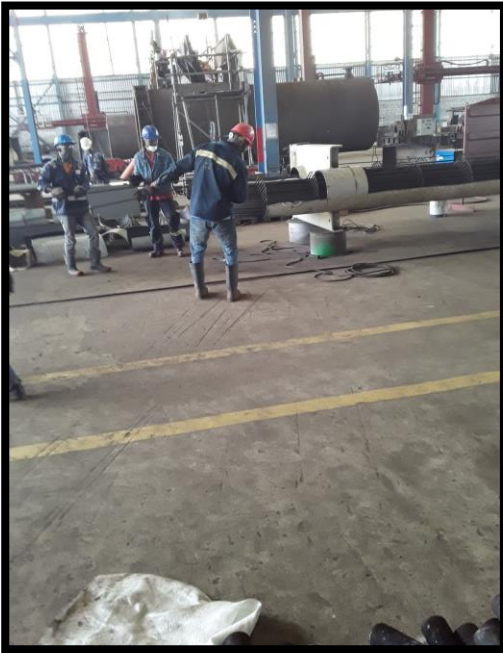
Marked Tubes Extraction

- Extraction of selected tubes.
- Cutting and tagging of selected sample tubes.

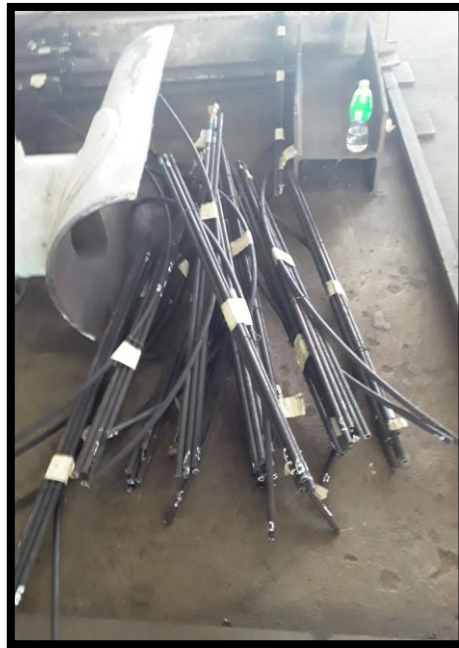
Extracted Sample Tubes

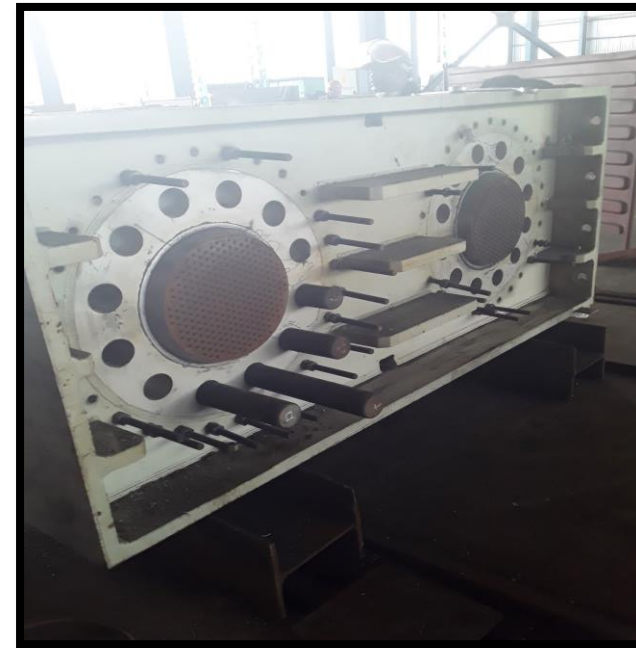
Exposed Tubesheet for Visual Inspection

- Removal of the flanges on the tube sheet, exposing the tubesheet for visual inspection.

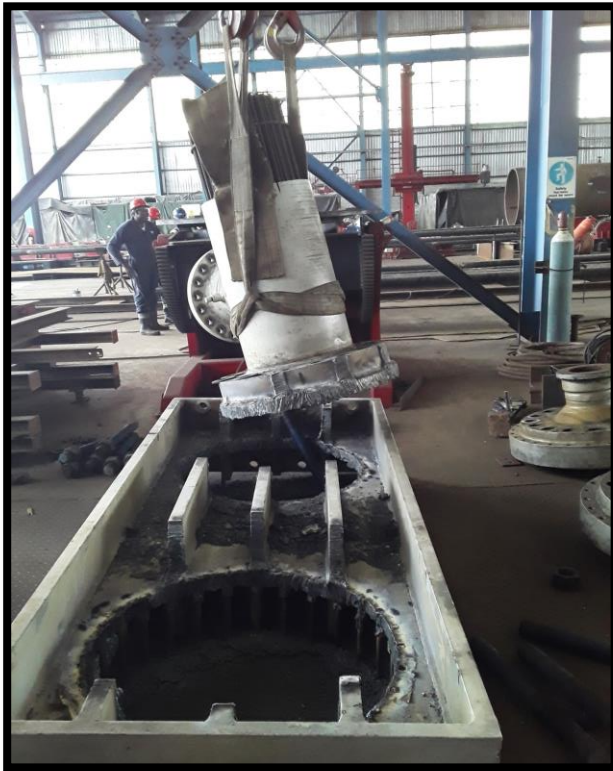
Tube sheet detached from the base support

- Detaching the tube sheet from the base support.
- Marking-out tubesheet sections for cutting.
- Cutting of marked-out tubesheet sections.

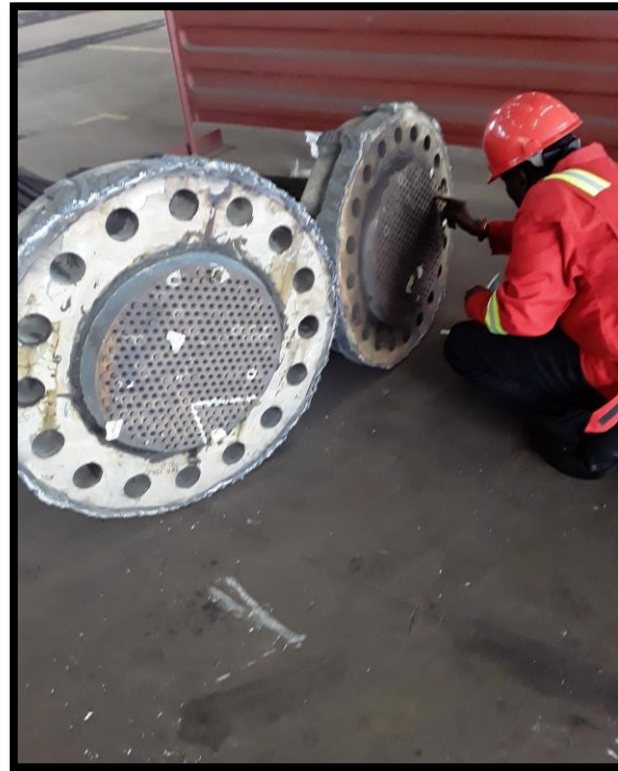
Marking out piece of tube sheet

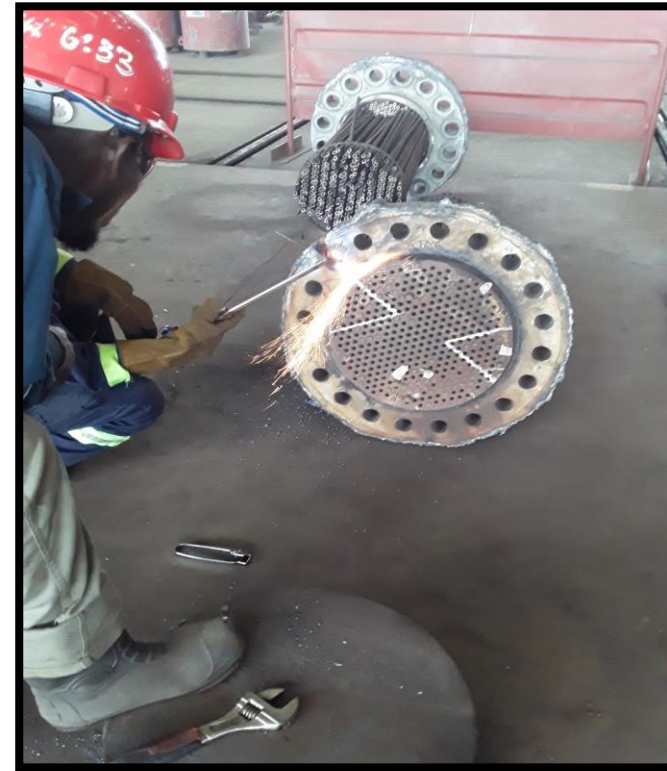
Tube sheet cutting

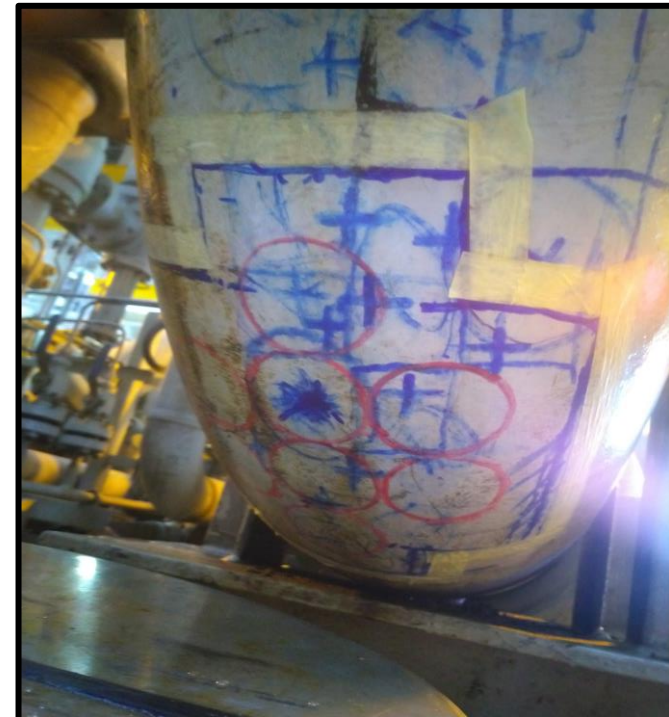
The monitoring locations (minimum thickness location and other seven locations) on the pipe elbow where the sensors will be installed, were marked out after being located using manual UT scan.

Marked out location for Sensor Installation

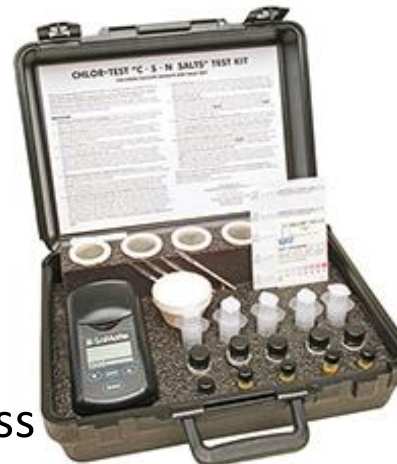
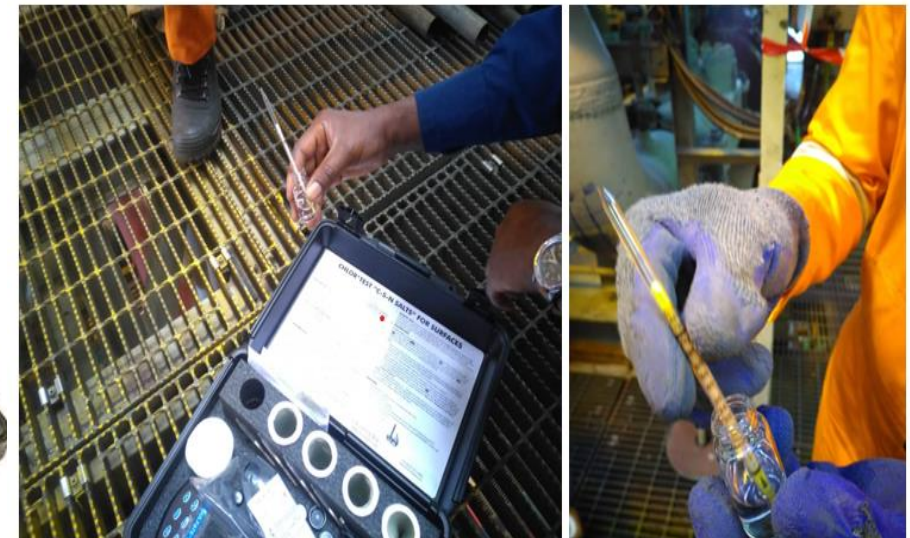
Elcometer 134 CSN Kit

Chloride test was essential because the location is offshore, therefore salt contamination is of great concern. Elcometer 134 CSN - Chlorides, Sulphates & Nitrates Kit was used in place of recommended Bresle chloride test kit. The maximum salt contamination must be less than 50 mg/m² (for carbon steel materials)

Conducting Chloride test

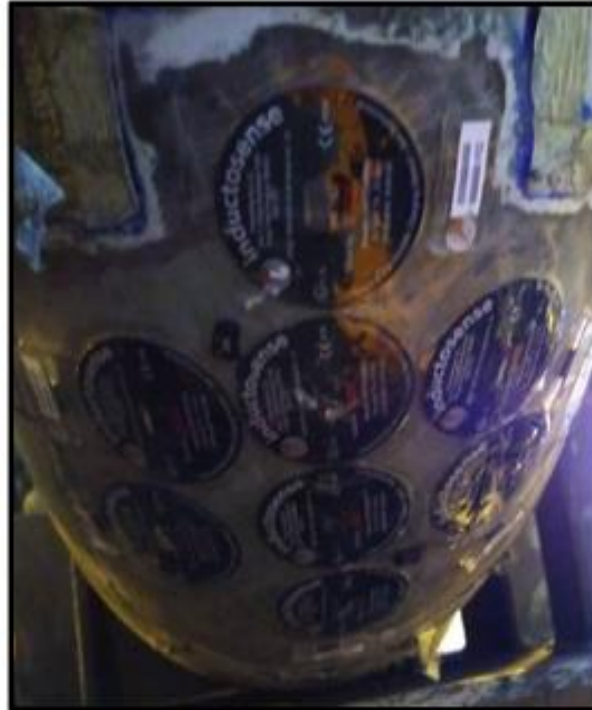
Sensor and RFID attachment was done in accordance with the approved installation manual.

Attached Sensors with RFID

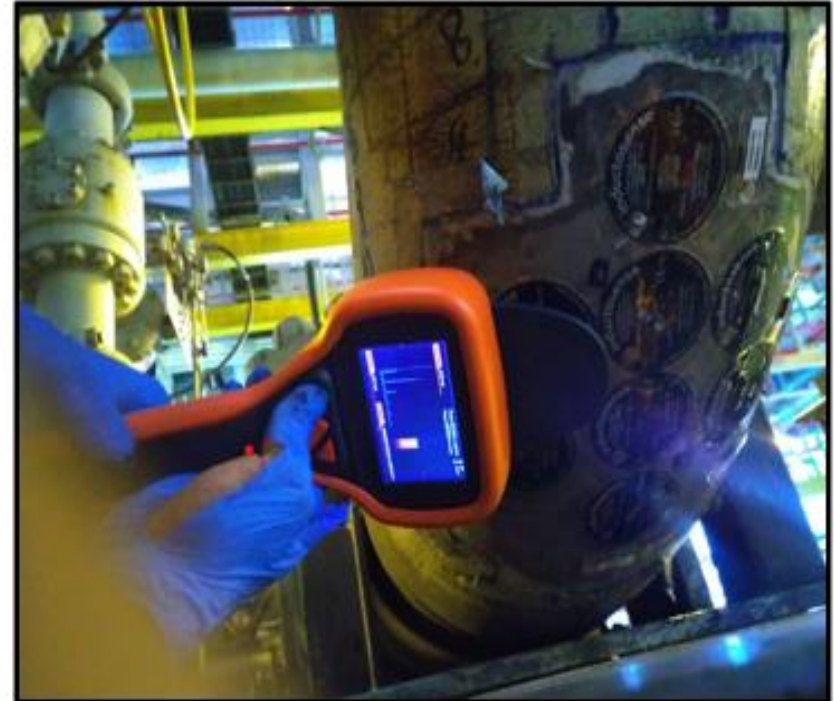
Testing for good signal after attaching the Sensors

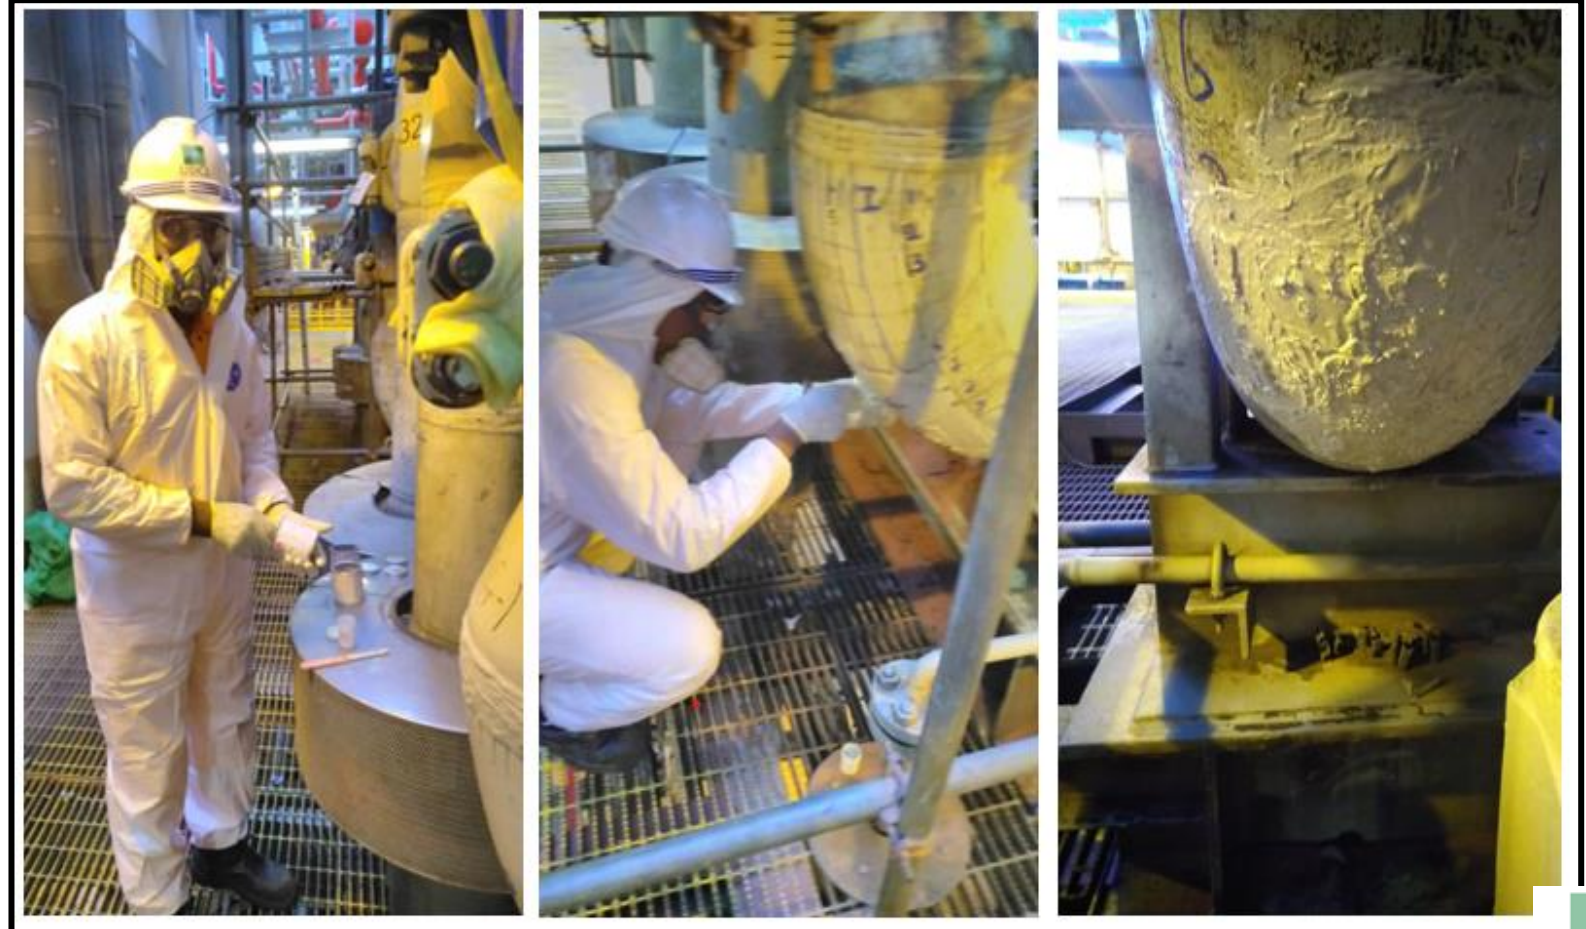
Protective Coating was done immediately RFIDs are placed and signals confirmed okay. This is to prevent significant oxidation or change in conditions before the final coating is applied

- Sanding tape removed/ replaced with tape for coating.
- Coating paste mixed and ready and be applied.
- Mixed paste applied and allowed to cure.
- Touch-ups done on the surface to ensure the area is properly cover with the ceramics coating paste.

Coating of Installation area
